CASE HISTORY

Holot Water Tower Preservation

Lesico LTD

Rishon-Le'zion, Israel

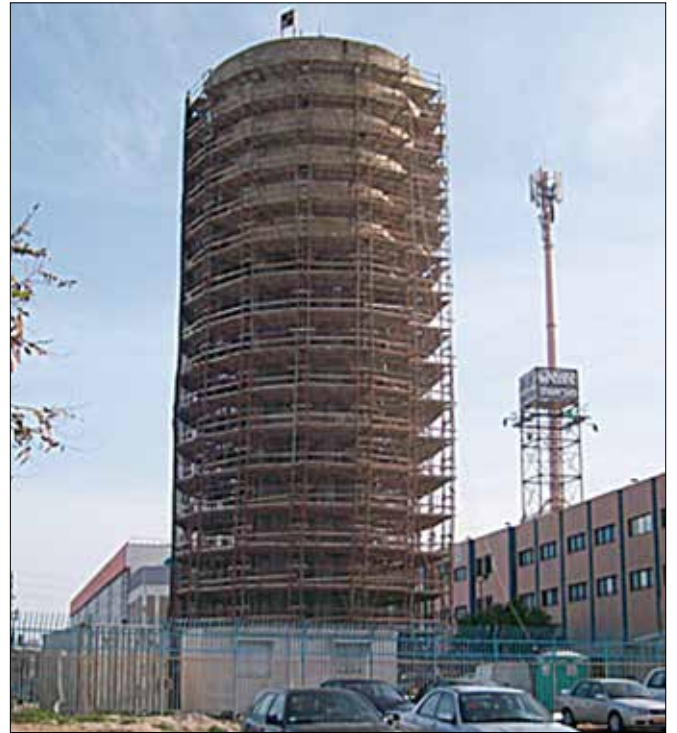
The 40 year old water tower developed cracking due to corrosion and leaks necessitating repair.

Holot Tower during restoration

First, all delaminated, unstable concrete was removed. Exposed reinforcing steel was cleaned and new concrete patches were placed. The entire structure was then treated with two coats of MCI®-2020 with a total dosage rate of 3.68 square meters per liter (150 square feet/gallon). Following MCI®-2020 application, bi-component PU paint was applied.

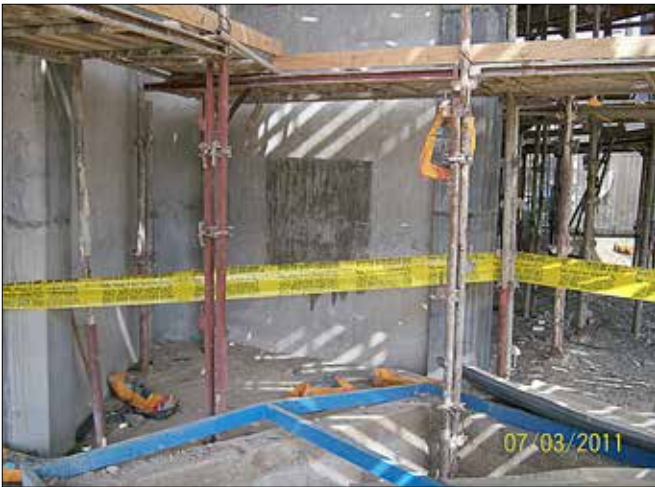
Demonstrating MCI®-2020 application on 1 Square Meter

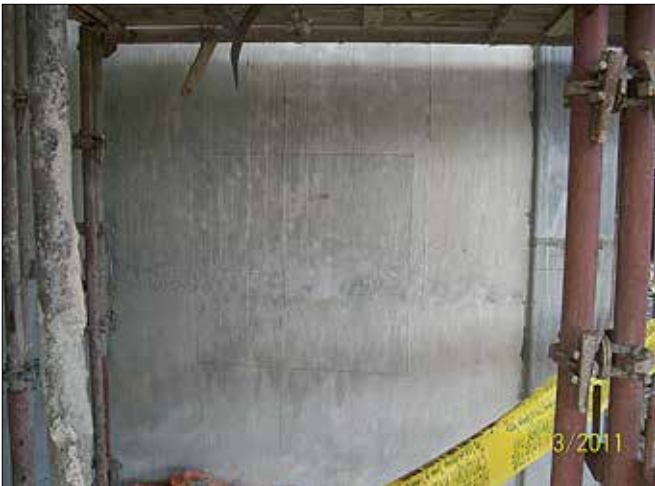
MCI®-2020 demonstration two weeks from application - almost undetectable

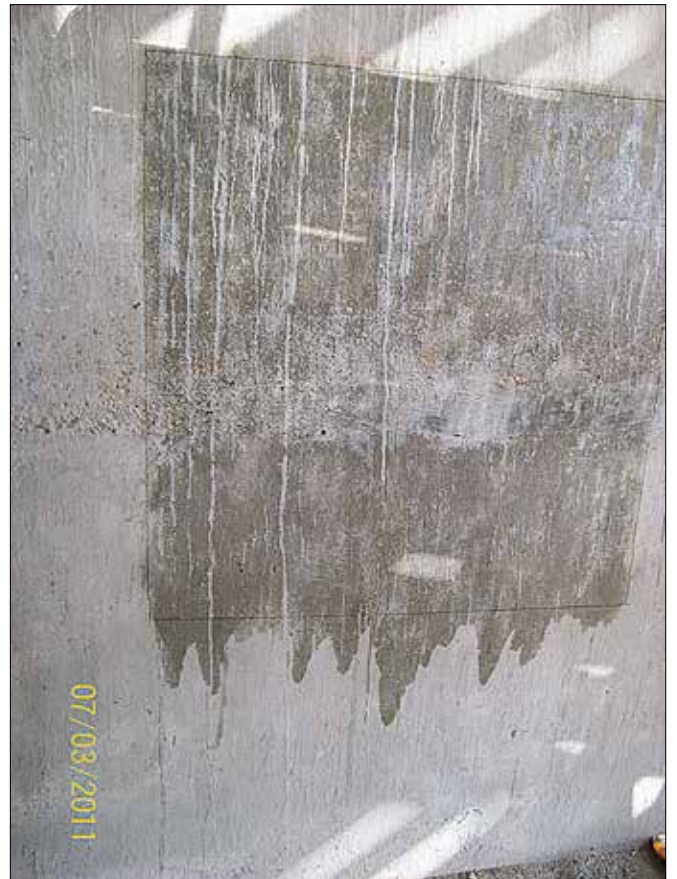
Demonstrating MCI®-2020 application on 1 square meter
