# CASE HISTORY

## Sharira Water Tower Preservation

Lesico LTD

Rishon-Le'zion, Israel

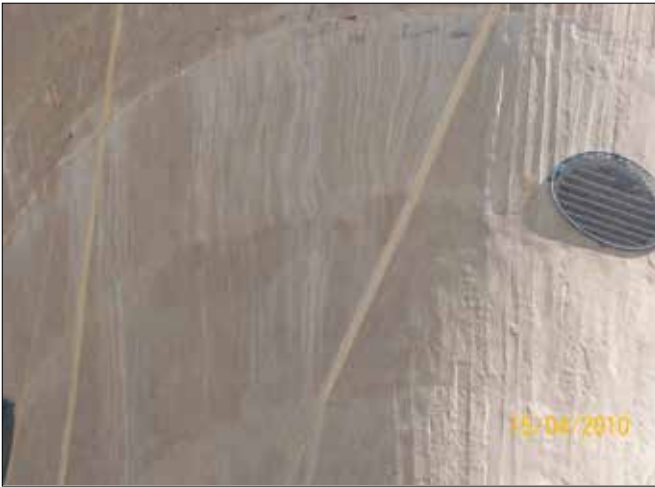
This is a second phase of repairs to a 40 year old water tower. This tower developed cracking due to corrosion and leaks necessitating repair.

**Water leakage and corrosion damage prior to restoration**

First, all delaminated, unstable concrete was removed. Exposed reinforcing steel was cleaned and new concrete patches were placed. The entire structure was then treated with two coats of MCI®-2020 with a total dosage rate of 3.68 square meters per liter (150 square feet/gallon). Following MCI®-2020 application, bi-component PU paint was applied.

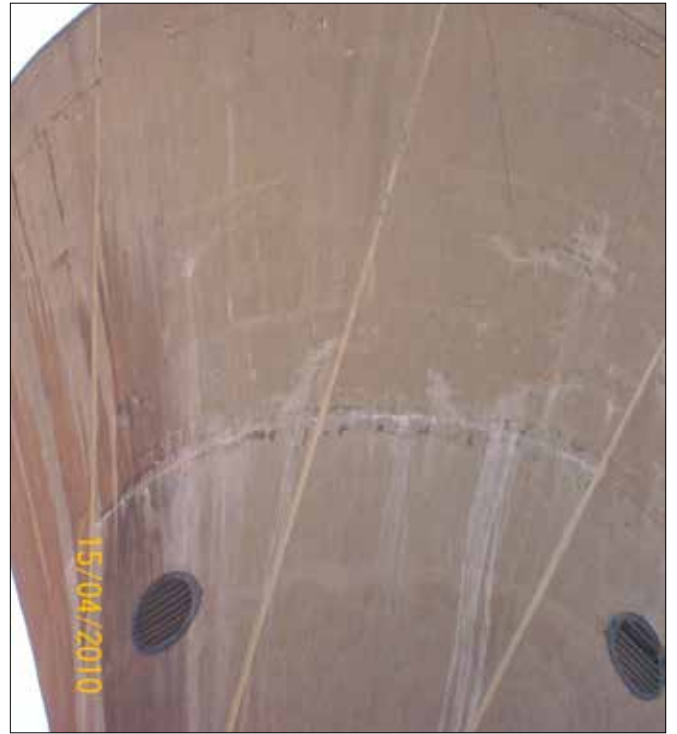
**Water leakage and corrosion damage prior to restoration**

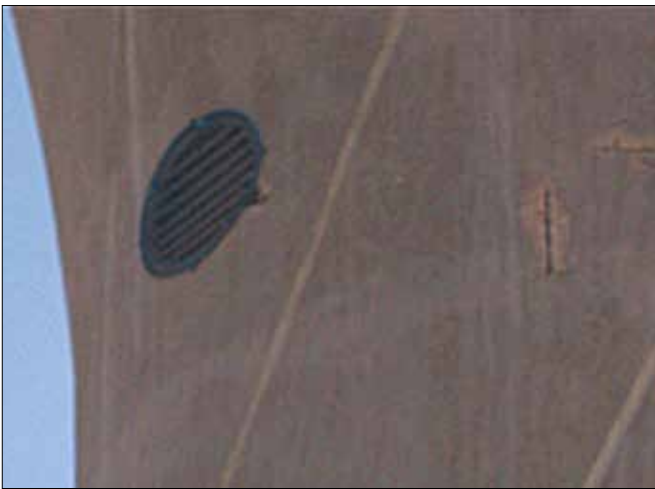
**Corrosion damage prior to restoration**

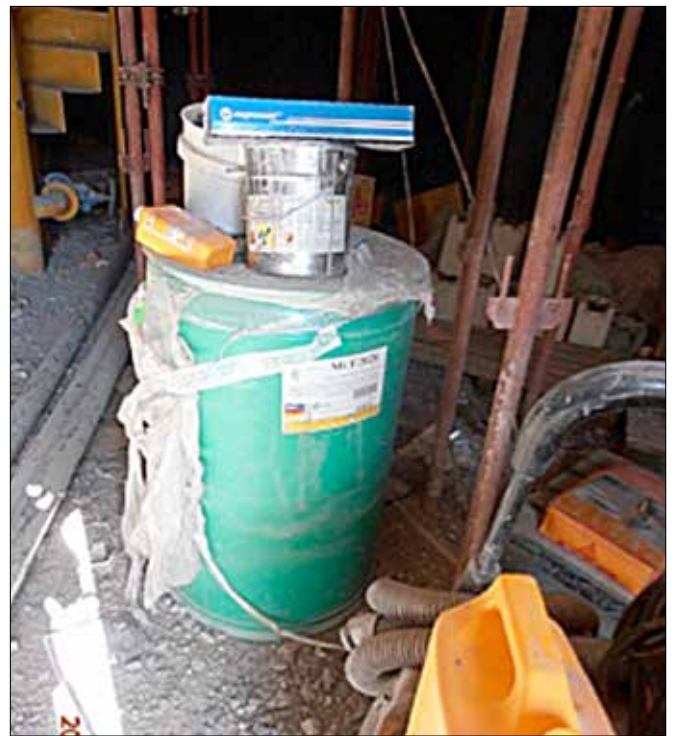
**Drum of MCI®-2020 waiting application**

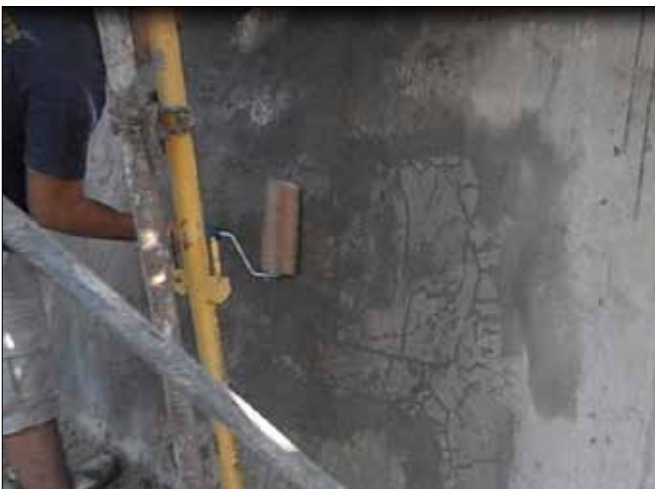
**Roller application of MCI®-2020 was chosen as wind around high exposed tower may carry spray droplets**

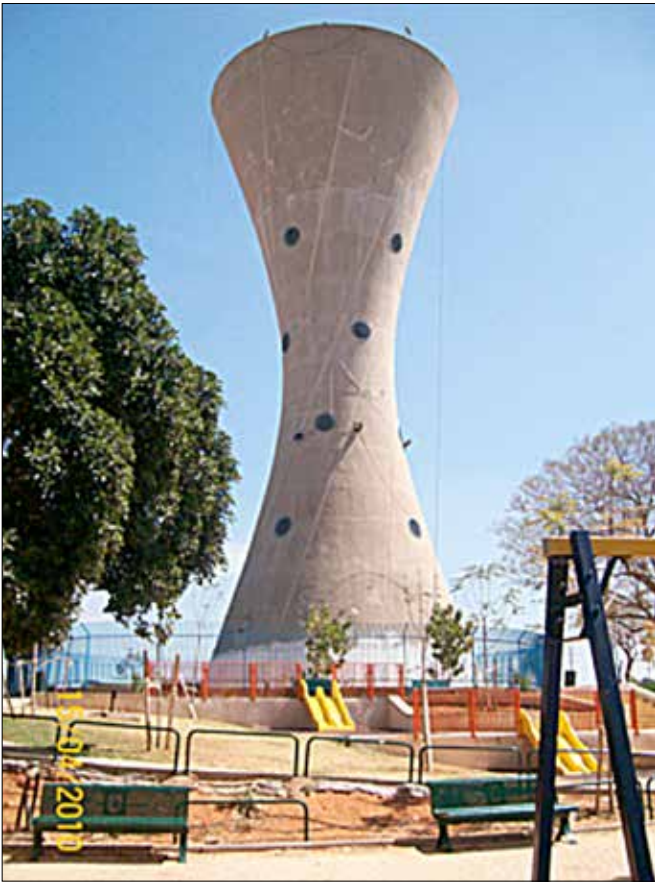
**Tower prior to restoration**

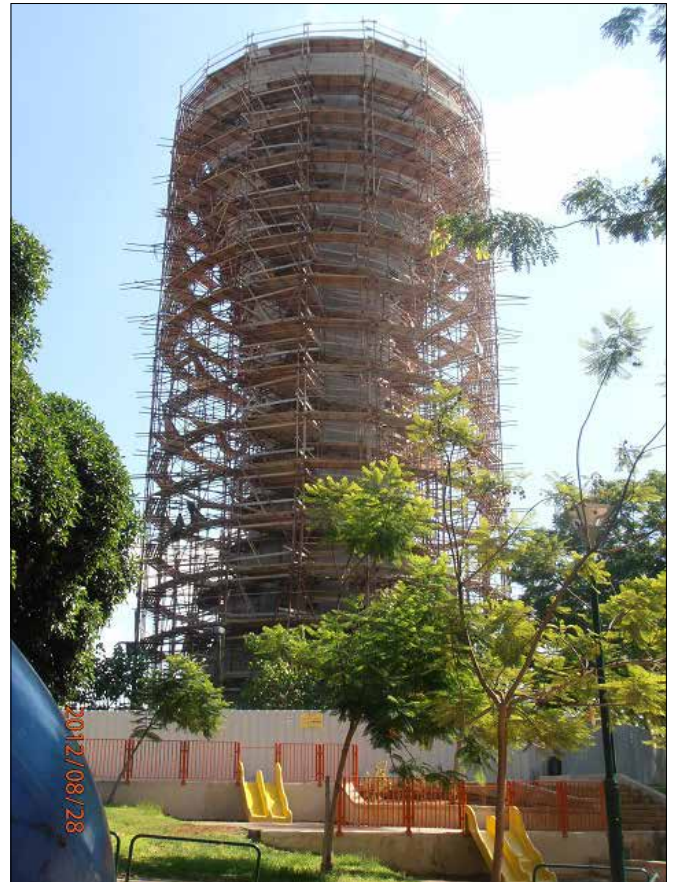
**Tower during restoration**
