# CASE HISTORY

## South Water Tower Preservation

This 25 year old water tower developed corrosion cracking, spalling and water leaks necessitating repair.

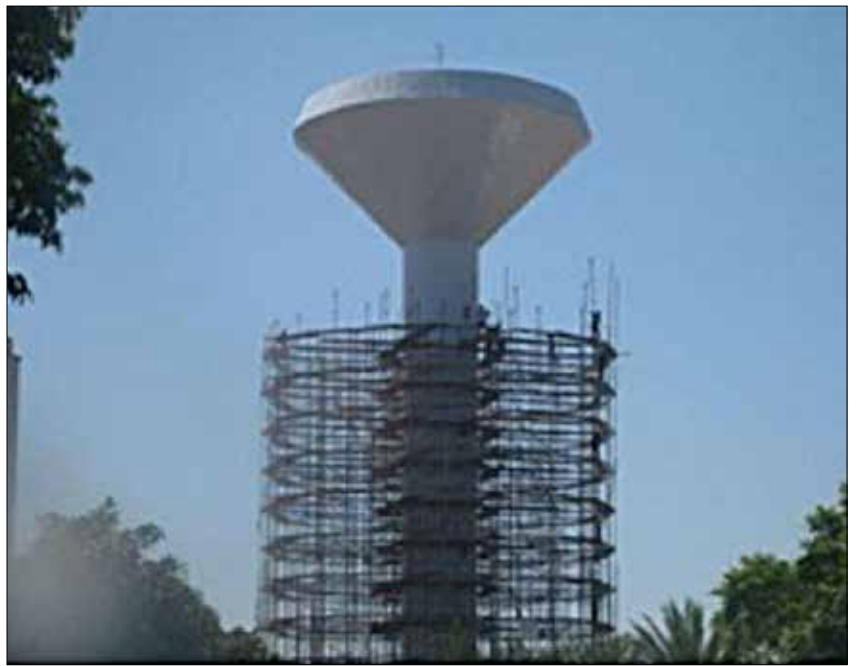
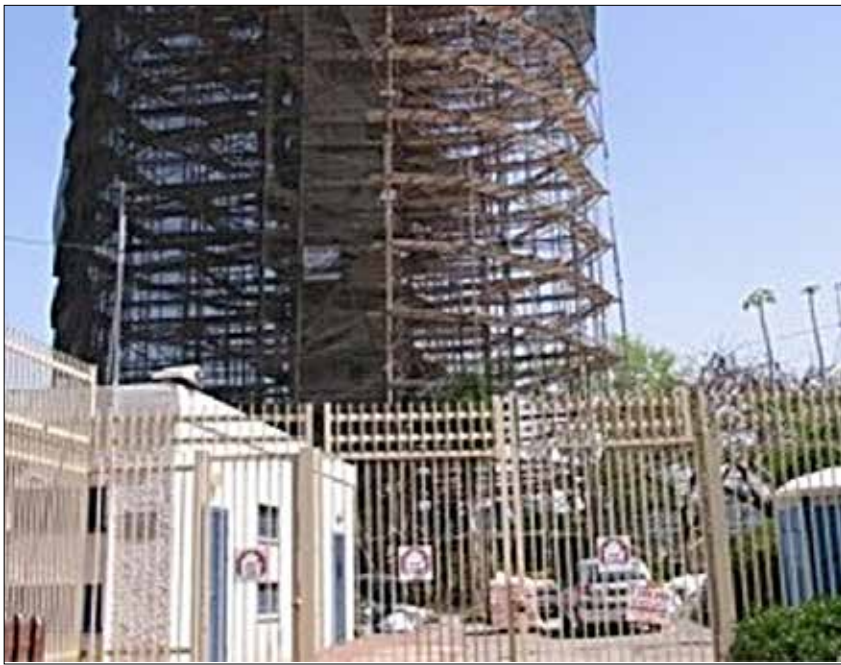
**South Tower during application.**

First, all delaminated, unstable concrete was removed. Exposed reinforcing steel was cleaned and new concrete patches were placed. The entire structure was then treated with two coats of MCI®-2020 with a total dosage rate of 3.68 square meters per liter (150 square feet/ gallon). Following MCI®-2020 application, bi-component PU paint was applied.

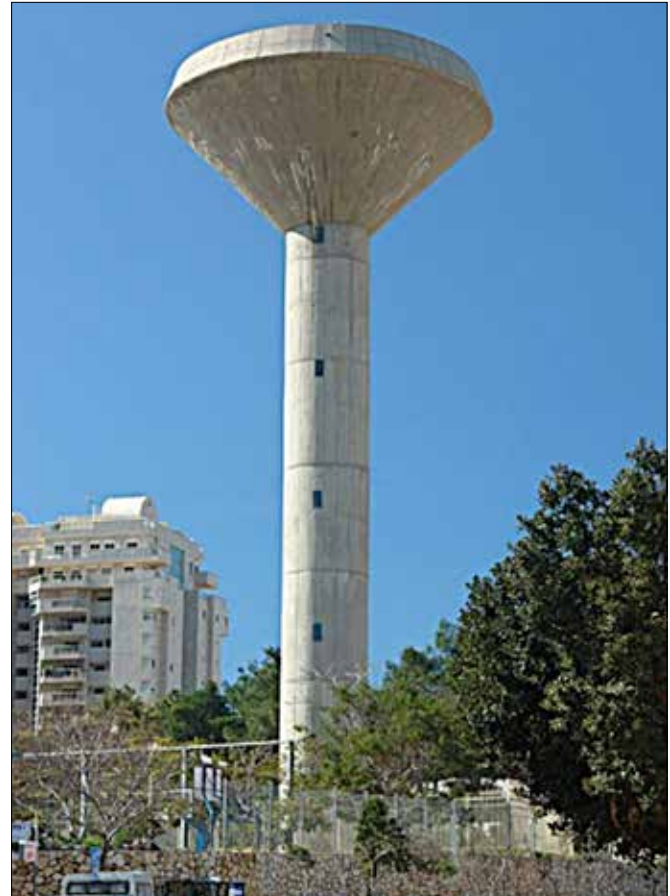
**South Tower prior to application.**
