CASE HISTORY

North Water Tower Preservation

ch460 1/2014 Page 1 of 2

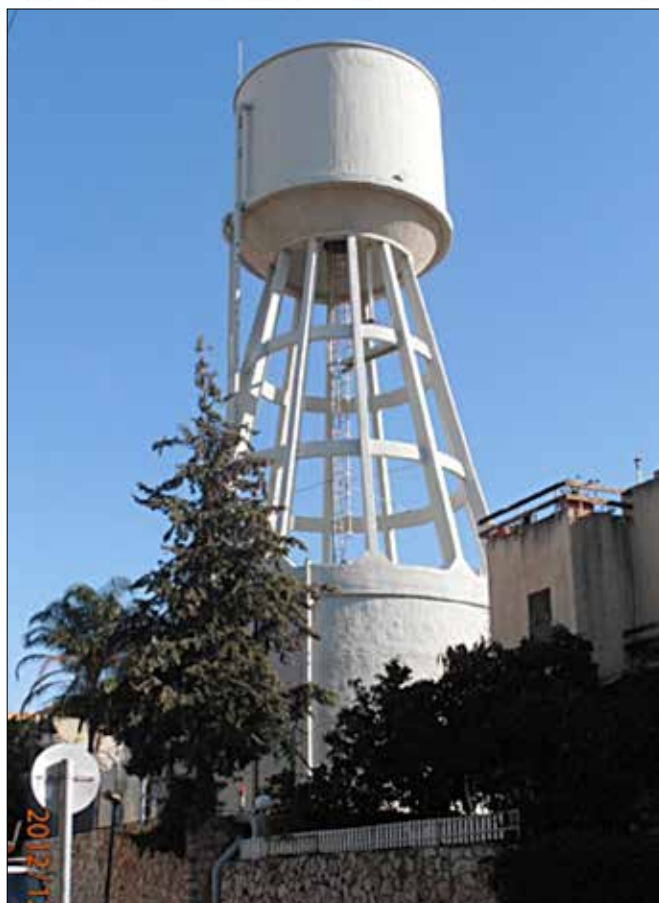
This 50 year old water tower developed corrosion cracking, spalling and water leaks necessitating repair.

First, all delaminated, unstable concrete was removed. Exposed reinforcing steel was cleaned and new concrete patches were placed. The entire structure was then treated with two coats of MCI®-2020 with a total dosage rate of 3.68 square meters per liter (150 square feet/ gallon). Following MCI®-2020 application, bi-component PU paint was applied.

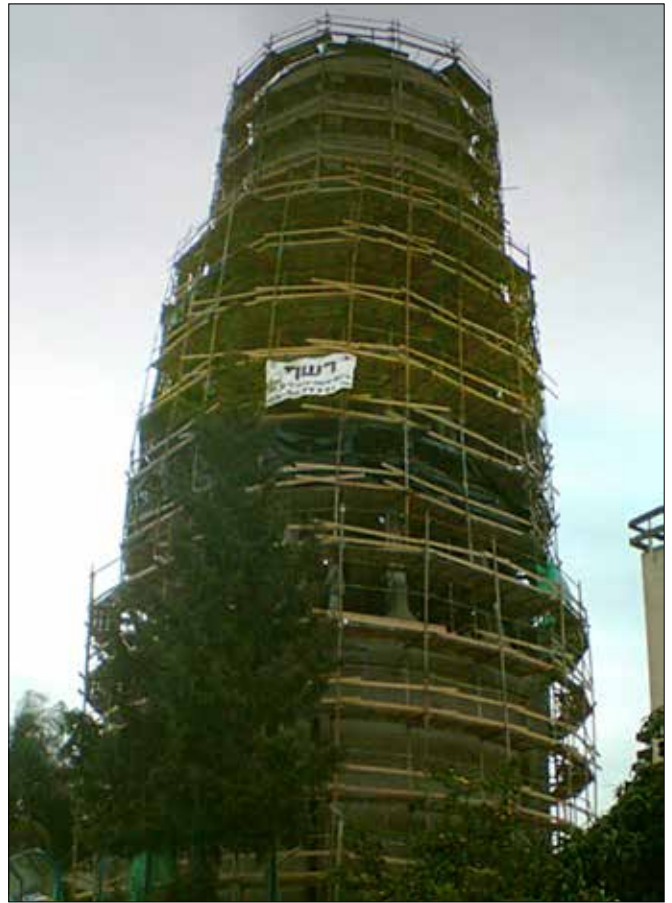
Ha'alia Hashnia Tower during preservation.

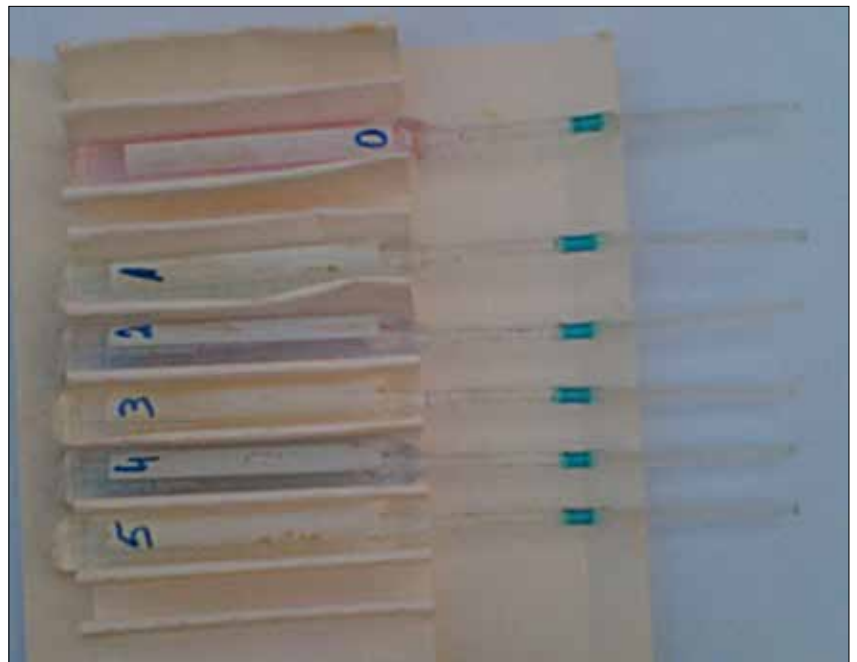
Tests of MCI®-2020 3 months after application: 5 concrete samples were taken from various locations on the tower. Vial marked 0 is reference de-ionized water. It was deducted that insufficient MCI®-2020 amount was applied at locations 1, 3, & 5, which were re-applied.
