CASE HISTORY

Stav Street Residential Building Restoration

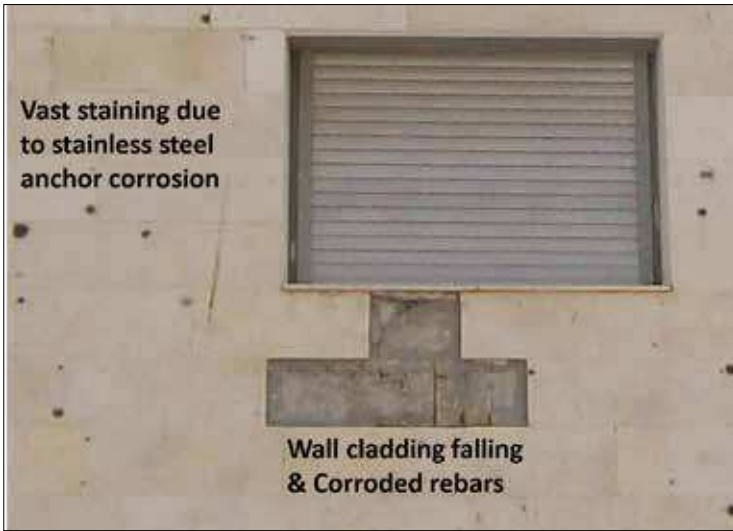
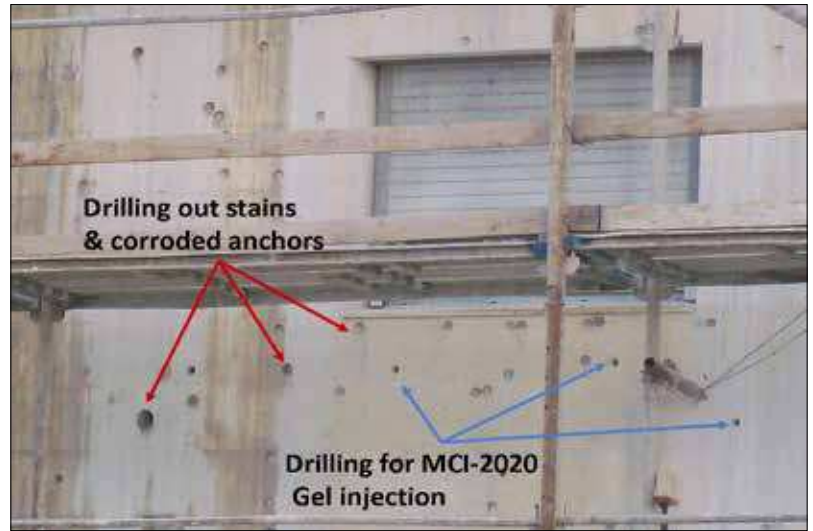
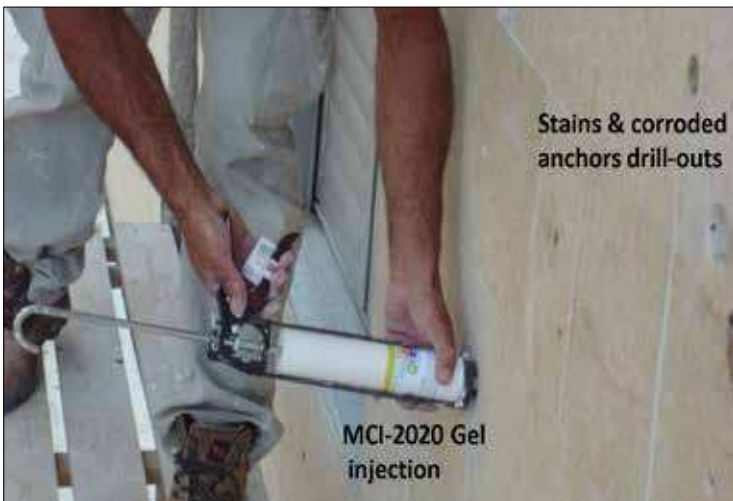
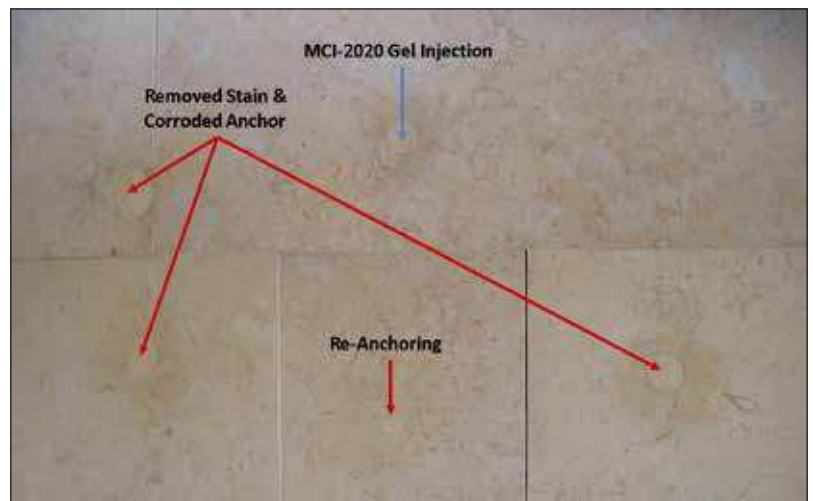
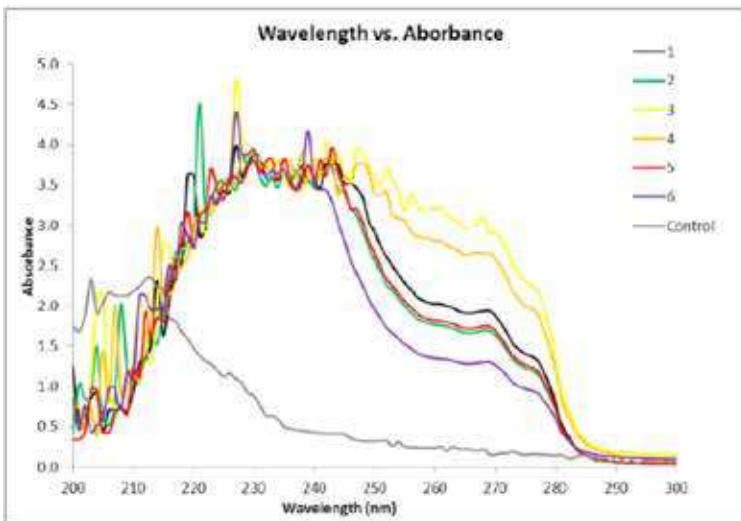
Problem: Stone cladding tiles began detaching and falling off a residential building only five years after its construction. The cause of the damage was diagnosed as corrosion of the building's concrete reinforcement and cladding anchors. After seven years of legal litigation (12 years from construction), it was ruled that restoration should include drilling and injection of MCI®-2020 Gel corrosion inhibitors.

The wobbling and cracked cladding tiles were removed first. MCI®-2020 Gel was injected into holes drilled through the cladding, and the holes were capped with cementitious mortar. All corroded anchors and stains were drilled out and filled with repair mortar. All tiles were re-anchored by new screws. To minimize the change in surface appearance, drilling locations were masked using caps prepared from the original cracked tiles.

The reconstruction project was deemed very successful. Six months after application, a test was performed that verified the presence of corrosion inhibitor throughout the concrete. Five years after application, a visual survey showed no appearance of new corrosion stains. The project was deemed very successful, and additional projects of a similar nature have since been completed in Israel.
