CASE HISTORY

BRANDEIS Water Tower Preservation

8 Brandeis Avenue, Herzlia, Israel

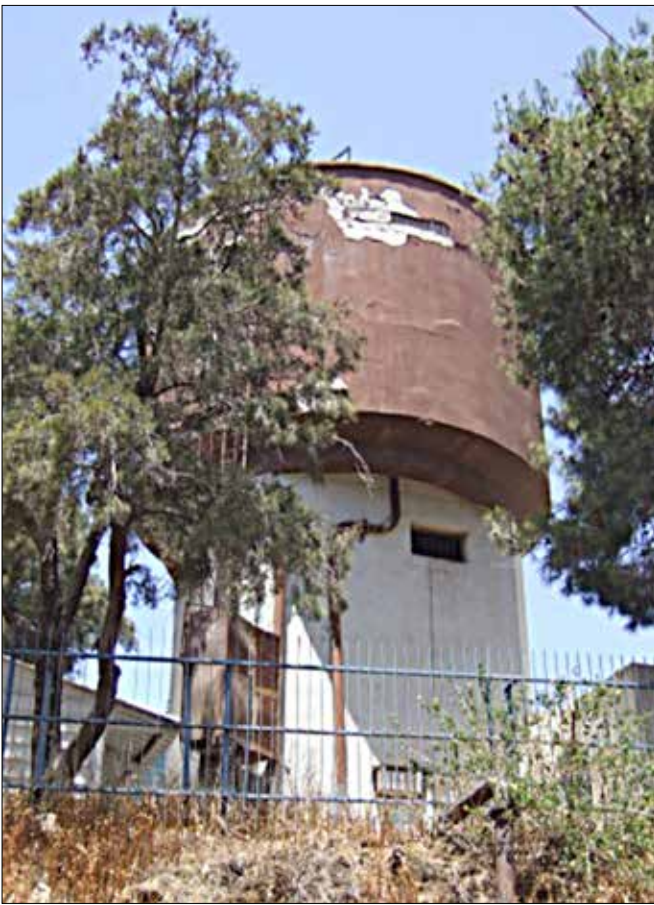
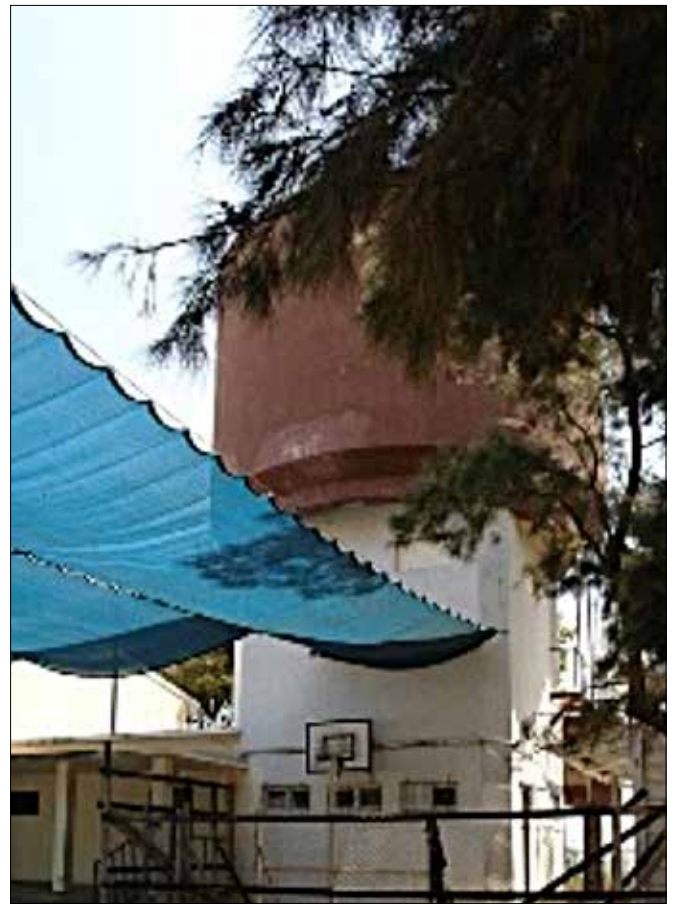
This 70 year old water tower developed corrosion cracking, spalling and water leaks necessitating repair.

Brandeis Tower prior to application.

First, all delaminated, unstable concrete was removed. Exposed reinforcing steel was cleaned and new concrete patches were placed. The entire structure was then treated with two coats of MCI®-2020 with a total dosage rate of 3.68 square meters per liter (150 square feet/ gallon). Following MCI®-2020 application, bi-component PU paint was applied.

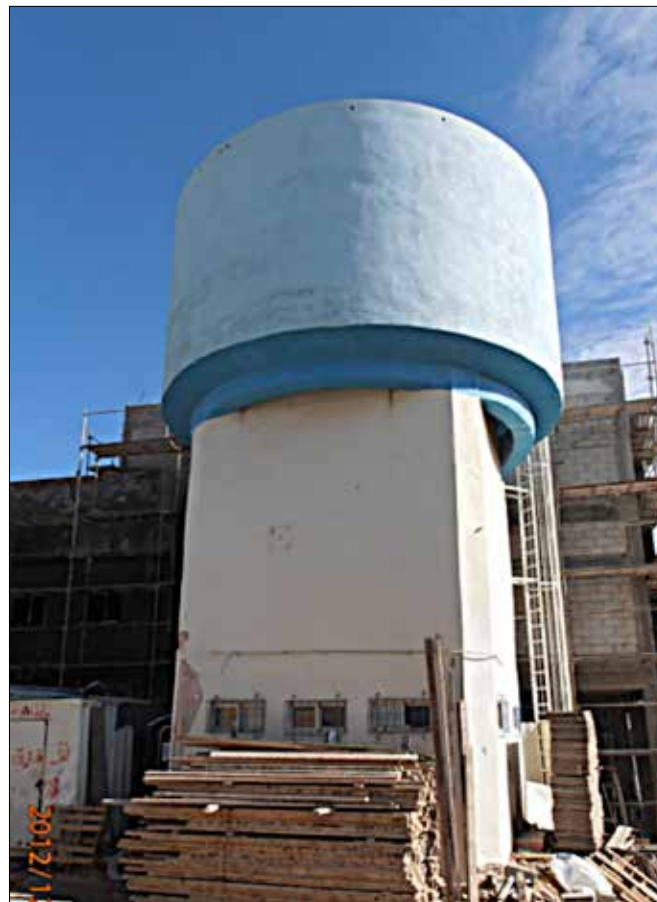
Brandeis tower during preservation.
